Wind Mitigation Inspection Report

511 99th Ave

St. Petersburg, FL 33702

Uniform Mitigation Verification Inspection Form

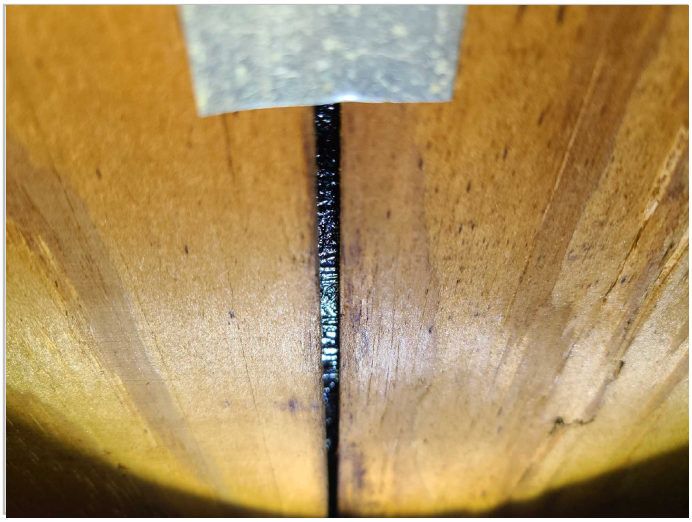
Roof Deck Attachment: 8D Nails (= or < 6” On Center)
