Wind Mitigation Inspection Report

794 100th Ave N

Pine Rush Villas Condo Association

Uniform Mitigation Verification Inspection Form

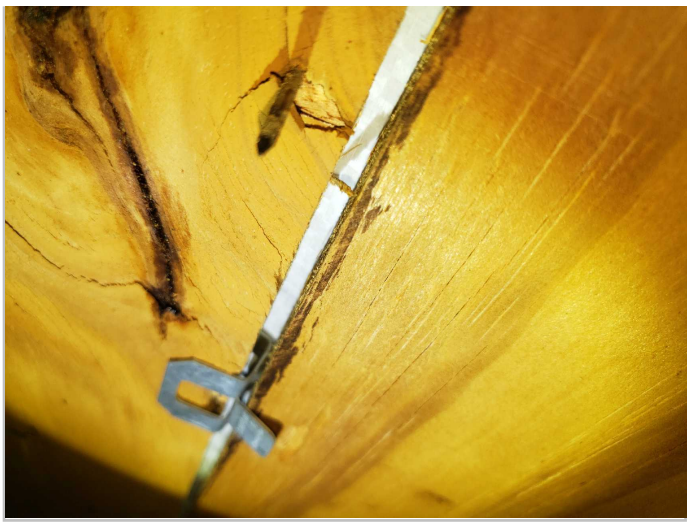
- ☐ Truss/rafter anchored to top plate of wall using nails driven at an angle through the truss/rafter and attached to the top plate of the wall, or
- ☒ Metal connectors that do not meet the minimal conditions or requirements of B, C, or D

Roof to Wall: Connectors Don't Meet Requirements
